RE: Progress report for November 2008 activities - Hecla Mining Company Apex Site (EPA ID No. UT982589848, Docket No. RCRA-8-99-06)

**MEMORANDUM TO:** Apex File  
**COPIES TO:** distribution  
**FROM:** Paul Glader  
**SUBJECT:** Progress Report No. 55 for period ending November 30, 2008; Pond 2 Final Closure - Apex Site, Washington County, Utah

# Annual Site Inspection Summary Sheet - Apex Site - Pond 2

TO: Paul Glader (Hecla Mining Company)  
FROM: Doug Gibbs (Monster Engineering Inc.)  
DATE: 11/4/08  
SUBJECT: **Surface Monument Survey Data Review – Apex Site**

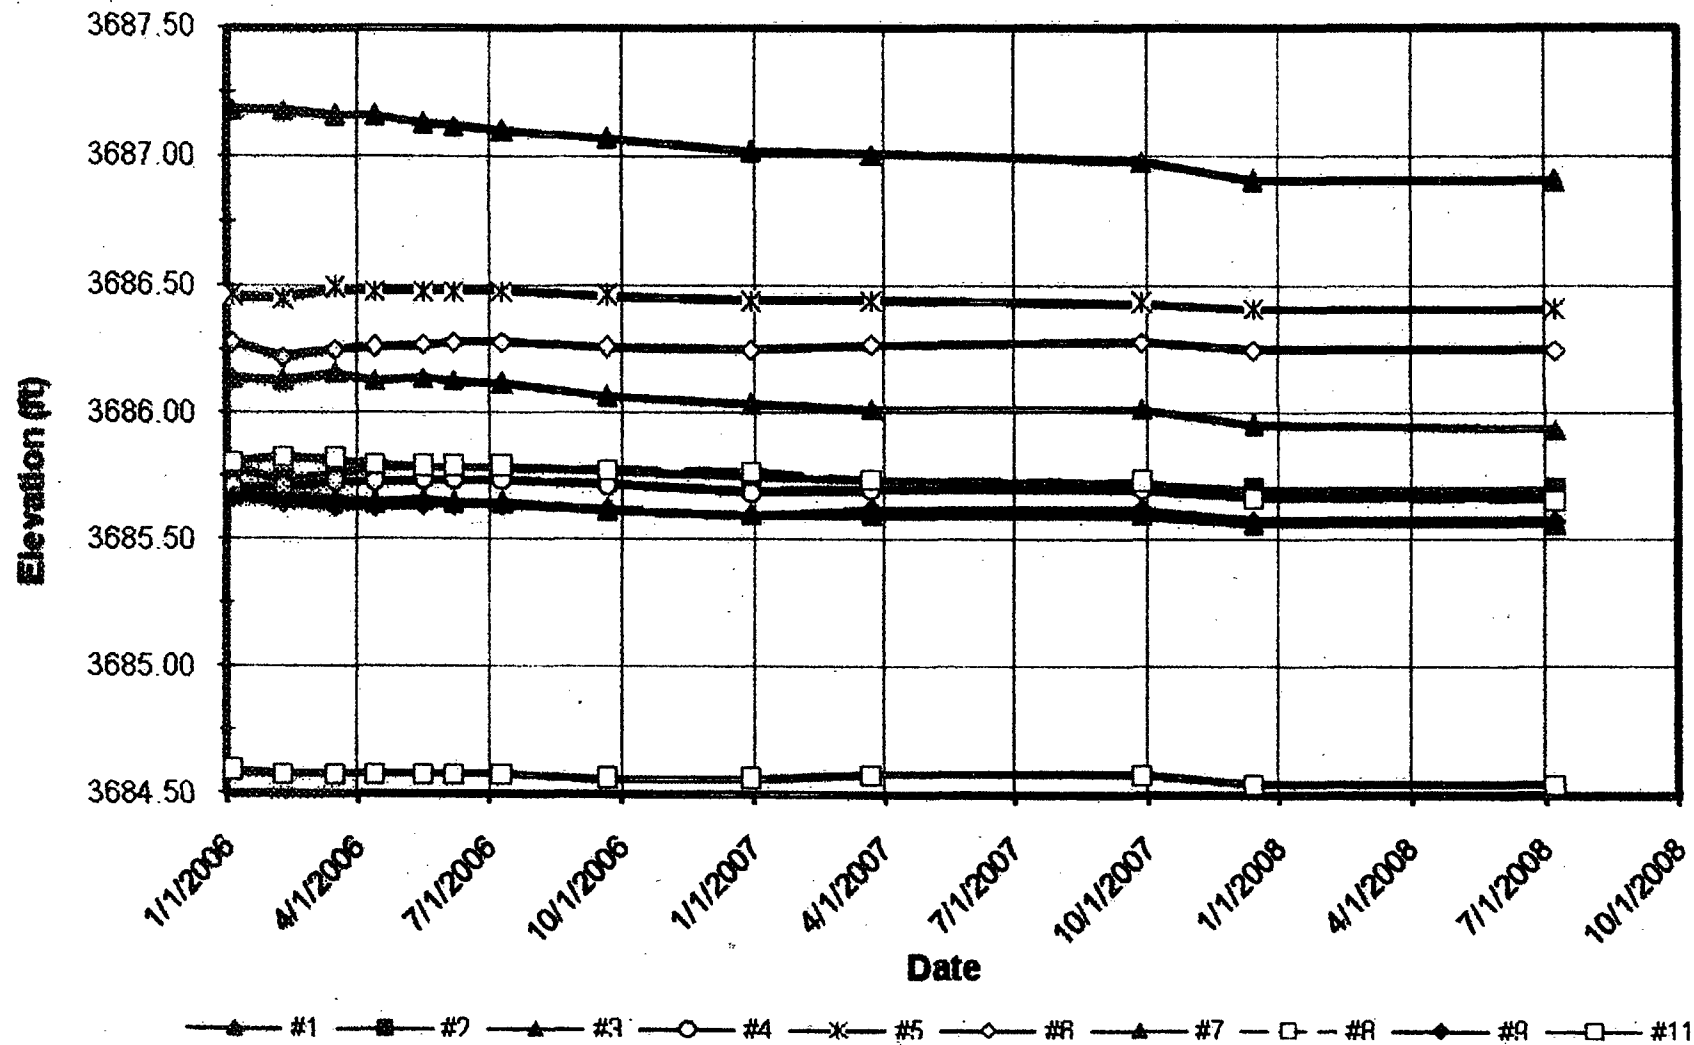
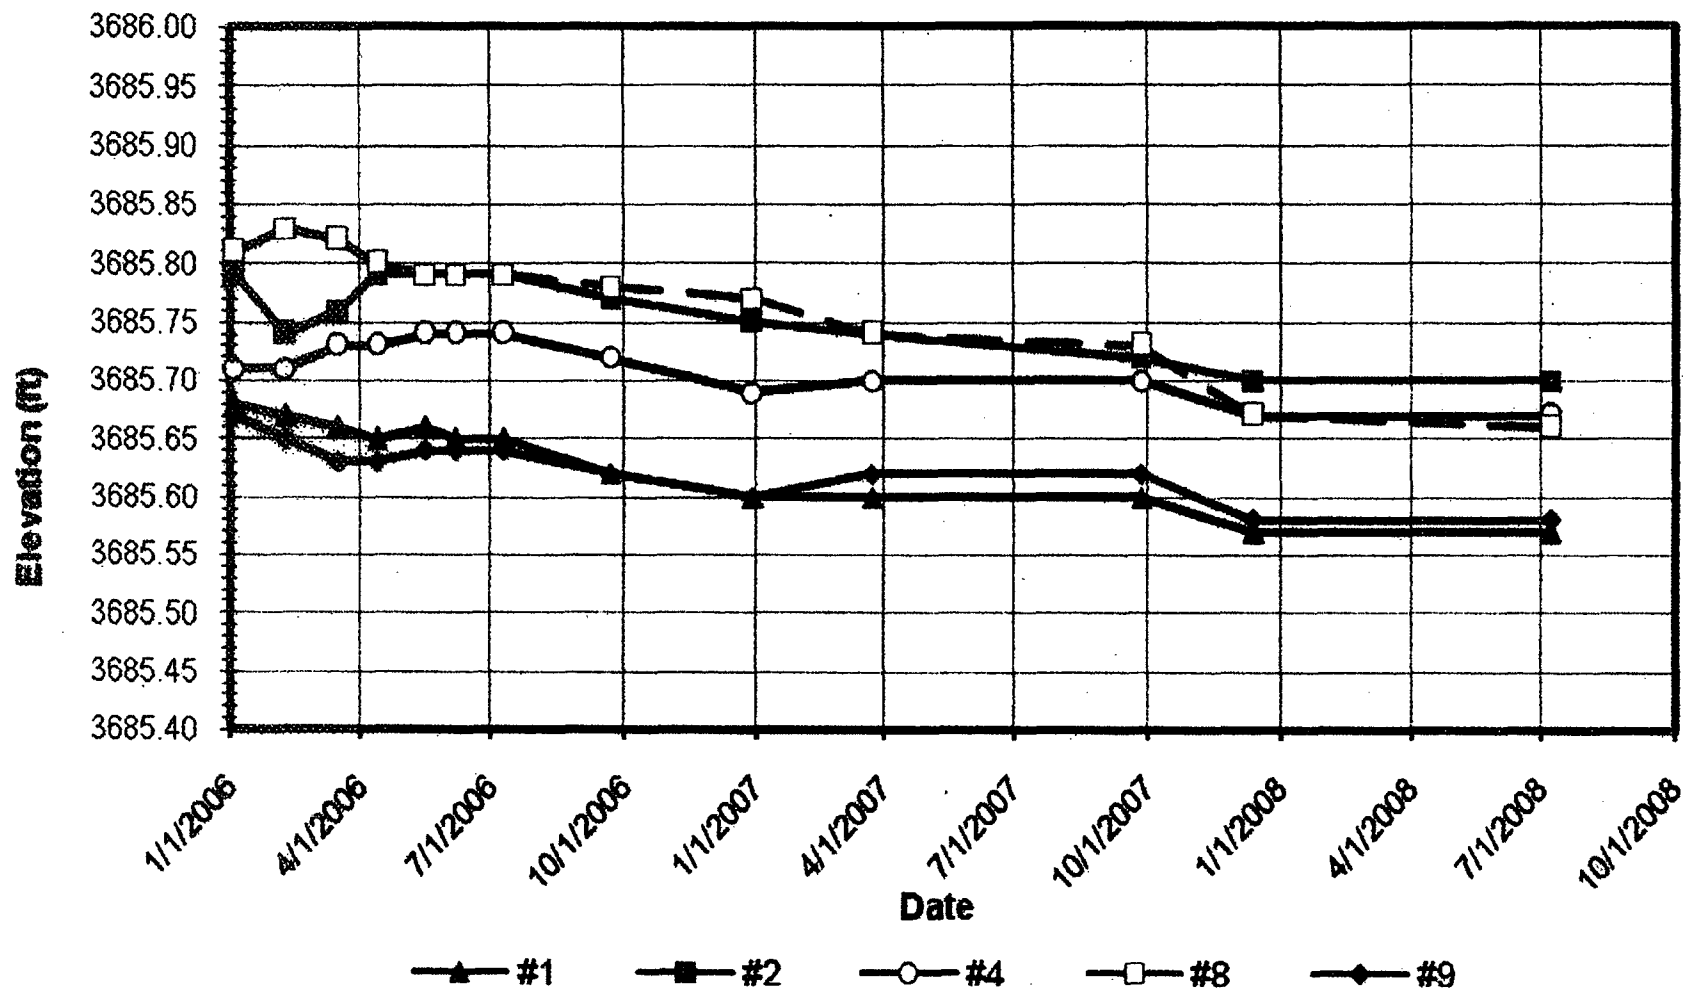
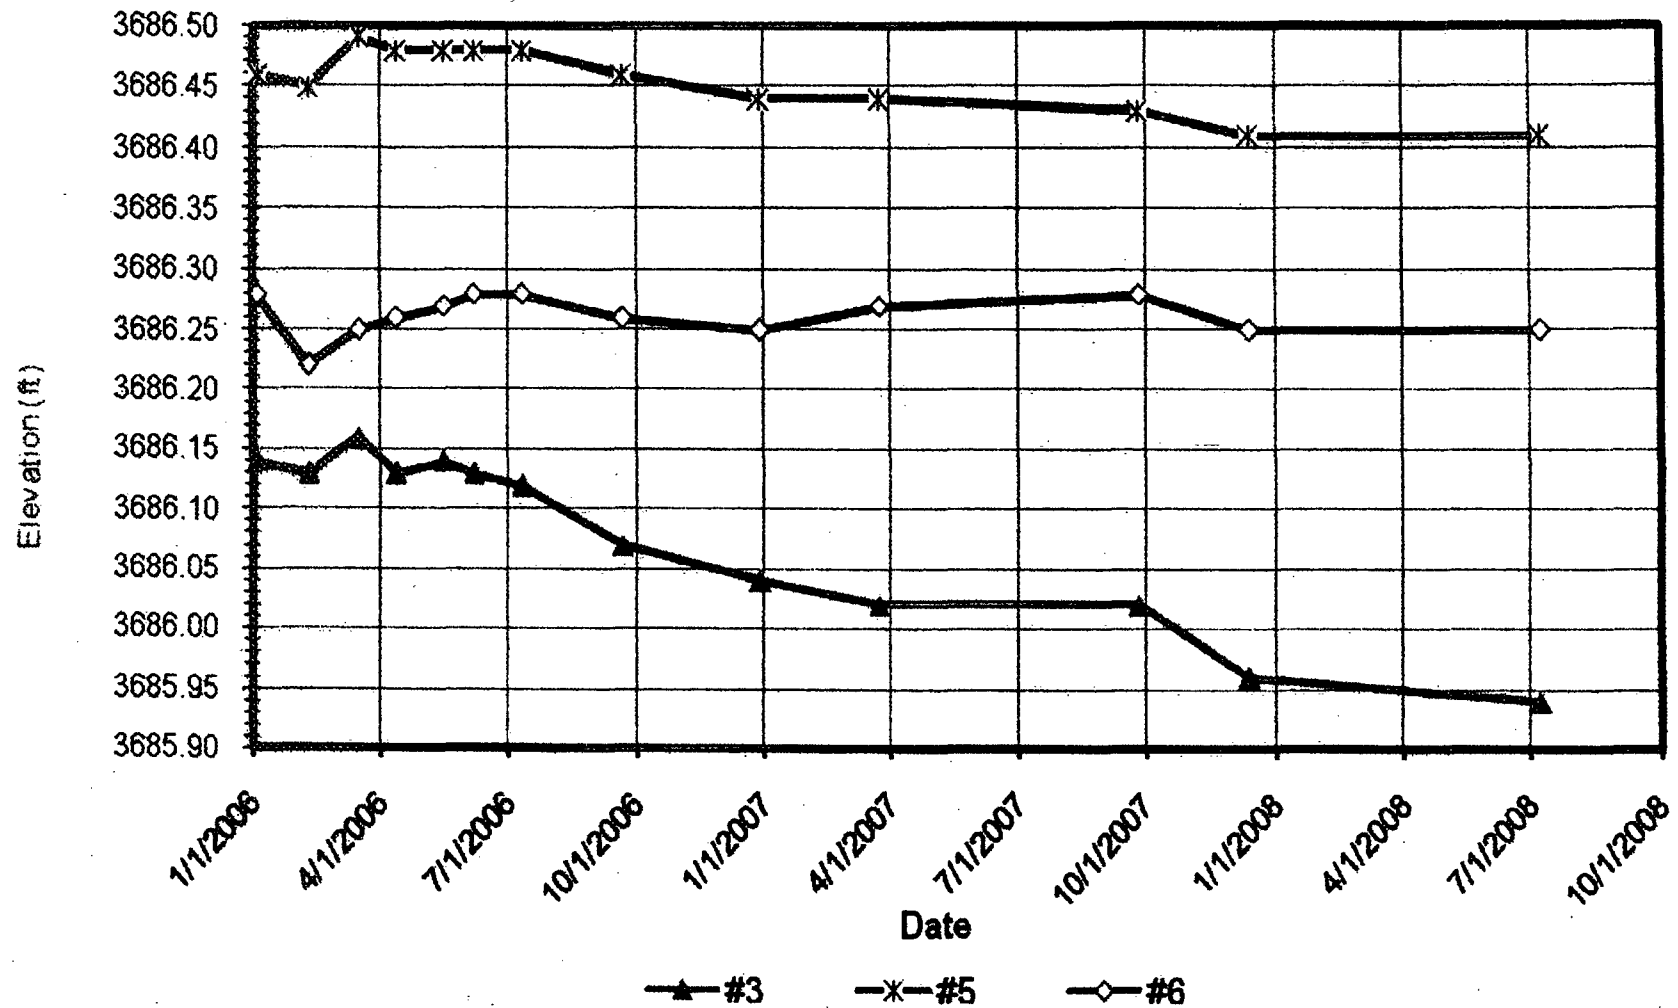
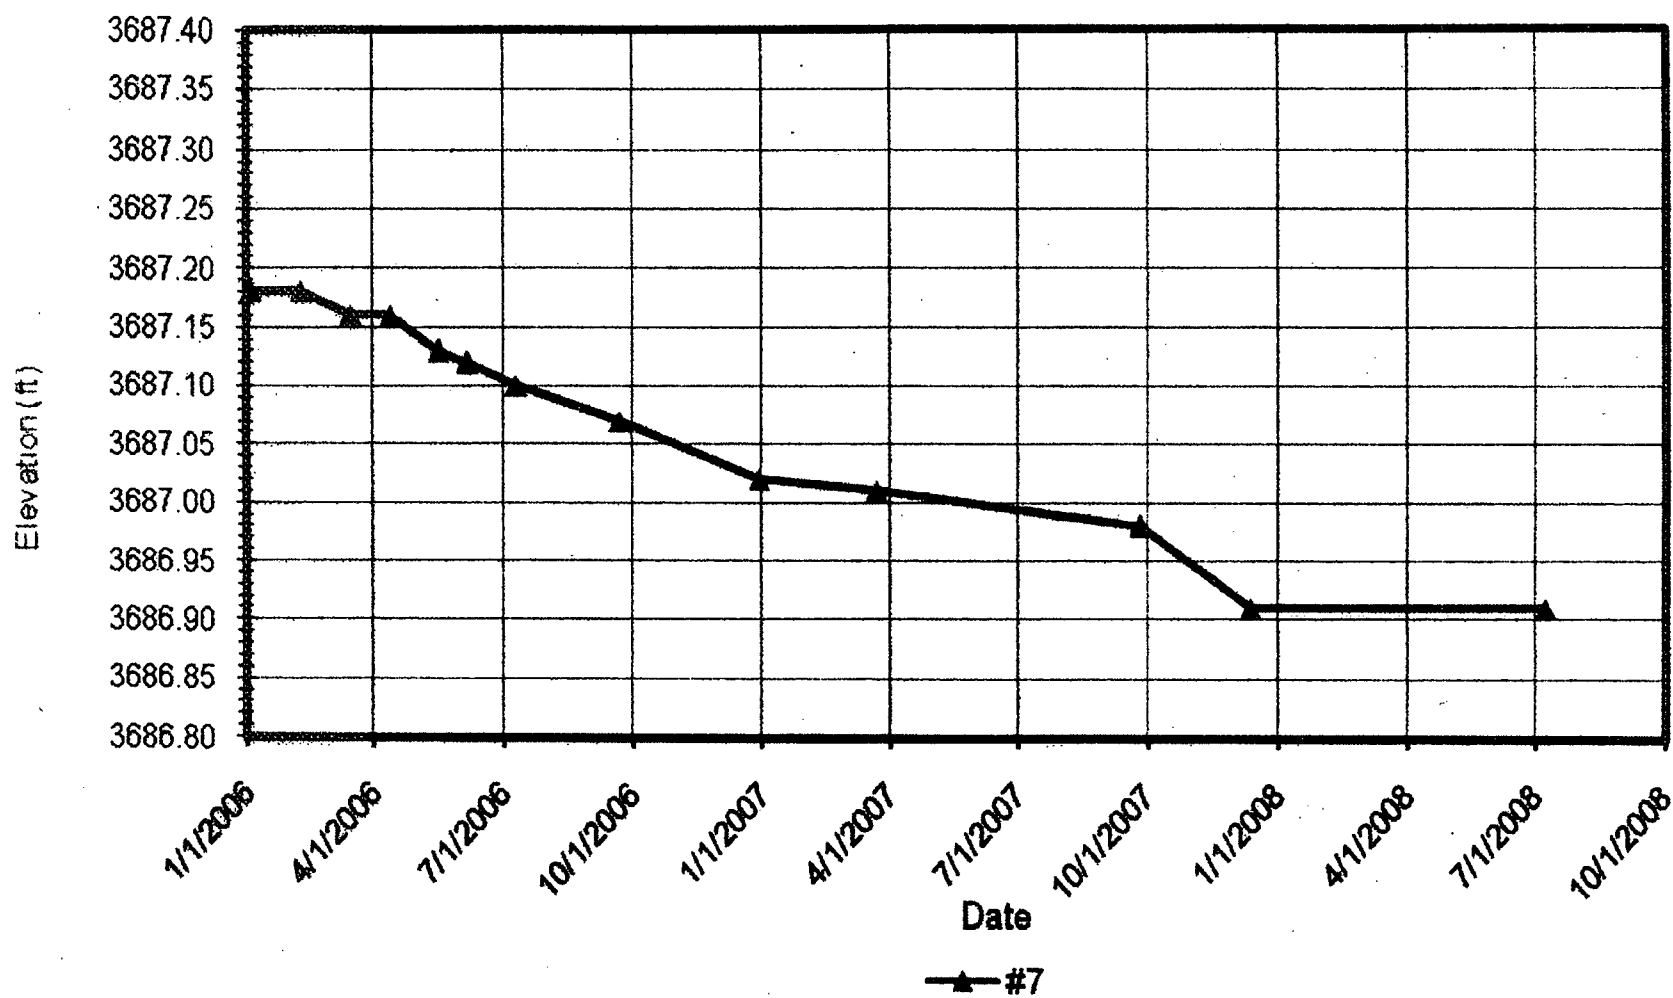
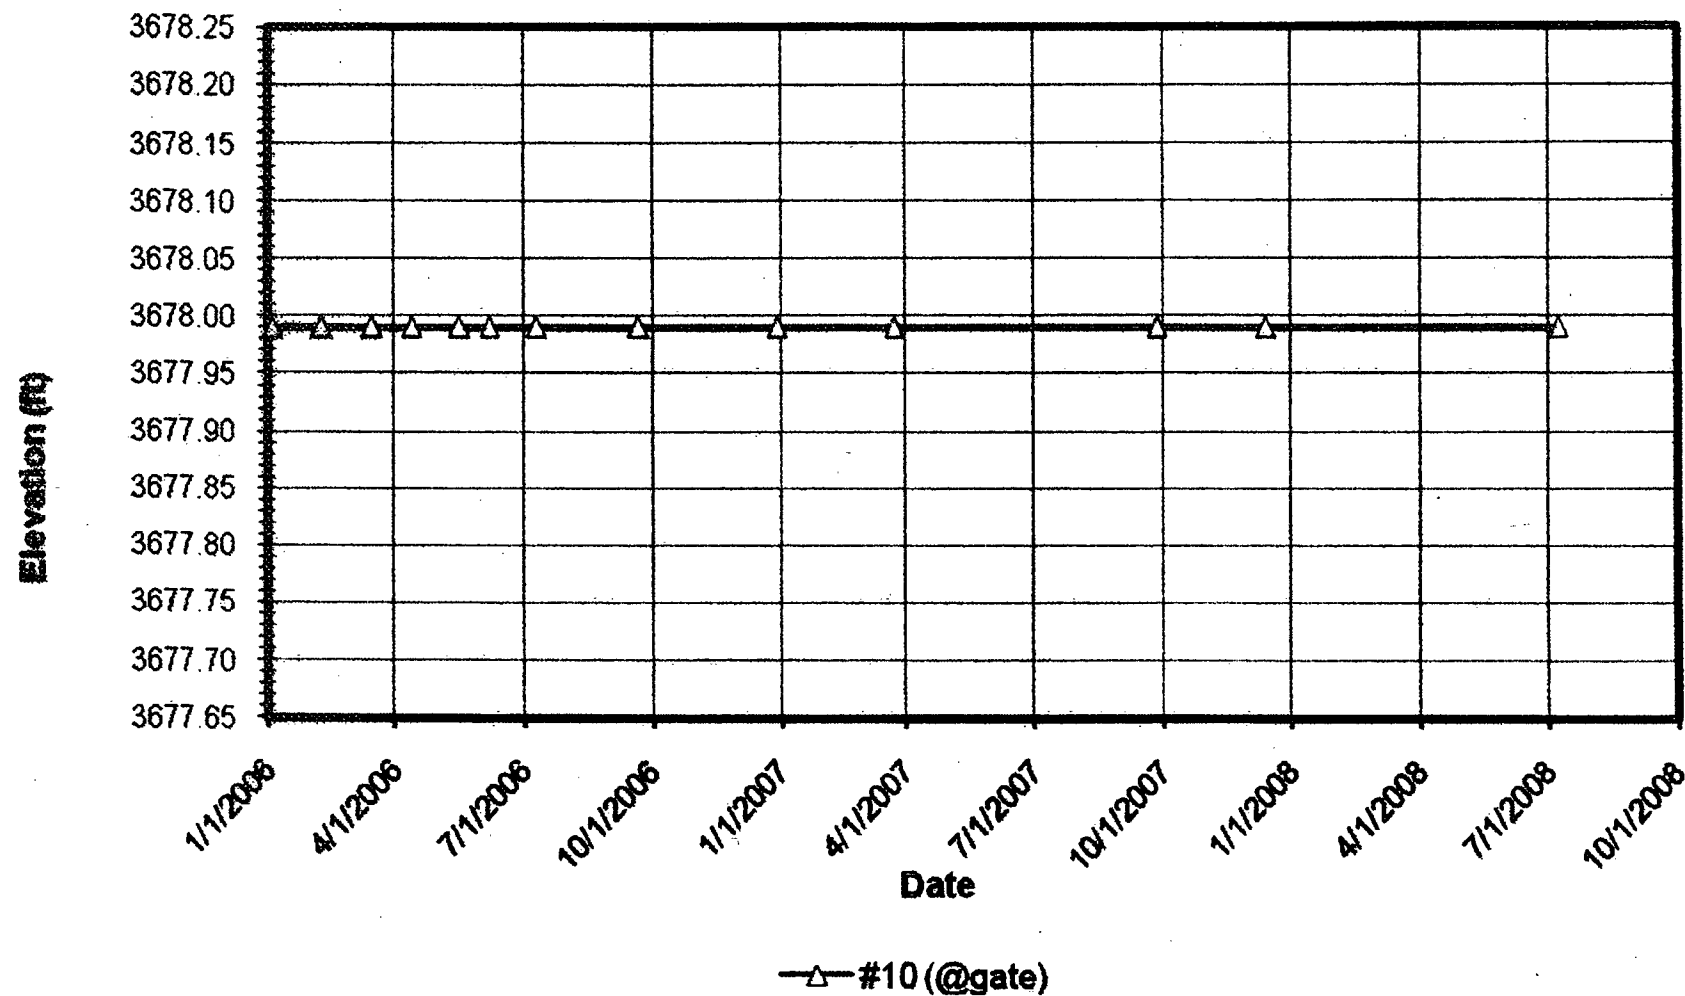
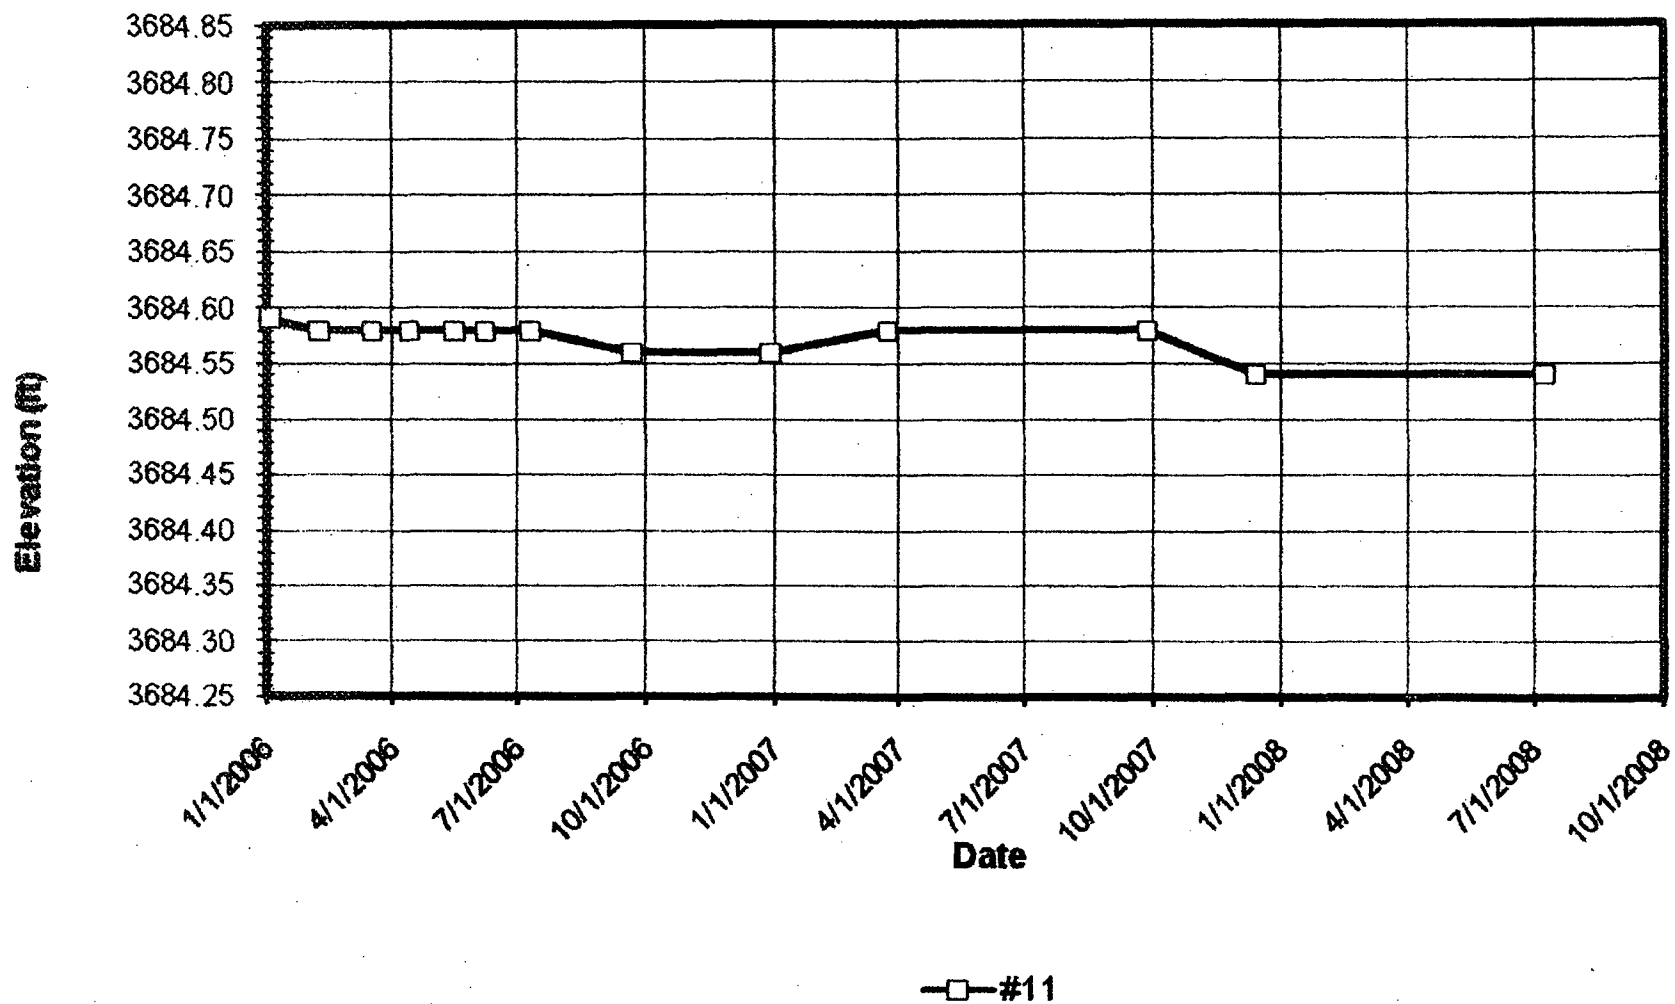
### Apex Pond 2 - Settlement Monument Elevations

Most apparent monument movement from period to period can be attributed to surveying accuracy limitations as the data shows individual monuments both increasing and decreasing in elevation. However, when data for all monuments is "corrected" by keeping the baseline monument's (#10) elevation change to zero, then a general trend of decreasing elevations becomes apparent.

In summary the data shows that roughly the northern half of the impoundment has settled between 0.05 and 0.27 feet. The southern half of the impoundment has remained very consistent with very little to no settlement (0.0 to 0.05 feet). The largest measured settlement is, as expected, near the center of the impoundment (monitor #7) at -0.27 feet. Slightly greater settlement in and nearer the center of the impoundment is to be expected as significant quantities of fill were placed in this area during construction. Additionally, greater settlement should be expected on the northern half of the impoundment based on the locations and methods utilized to place the original cover materials (prior to final reclamation activities). According to Chris Gypton and Alan Wilson, cover materials were initially placed in the southwest corner and generally moved across the impoundment towards the northeast corner. This created a mud wave of unconsolidated waste which moved towards this corner, and eventually a thicker deposit of unconsolidated waste materials.

There continues to be no concerns to date with settlement. There are no low spots and no signs of ponding rain water. As expected with long-term consolidation, the data shows that settlement rates are slightly decreasing over time. Consolidation of waste materials and final reclamation cover materials appears to be very minimal and decreasing. Additionally, it is highly unlikely that any liquids are leaving the impoundment.

All elevation data provided by Alpha Engineering is presented graphically on the following pages. The first graph shows all monuments (except monitor #10 the baseline point) on a scale that allows all data to be compared. The next five graphs have expanded "Y" axes scales in order to more clearly show elevation changes, and for ease of comparison between graphs. A monument location map (provided by Alpha Engineering) is attached on the last page of this document. Included on this map are contours showing approximate total settlement of the top surface since installation of the monuments.

Based on data collected to date, MEI recommends that Hecla continue with their current plan and collect elevation data semi-annually. Please contact me if you have any questions concerning this review.

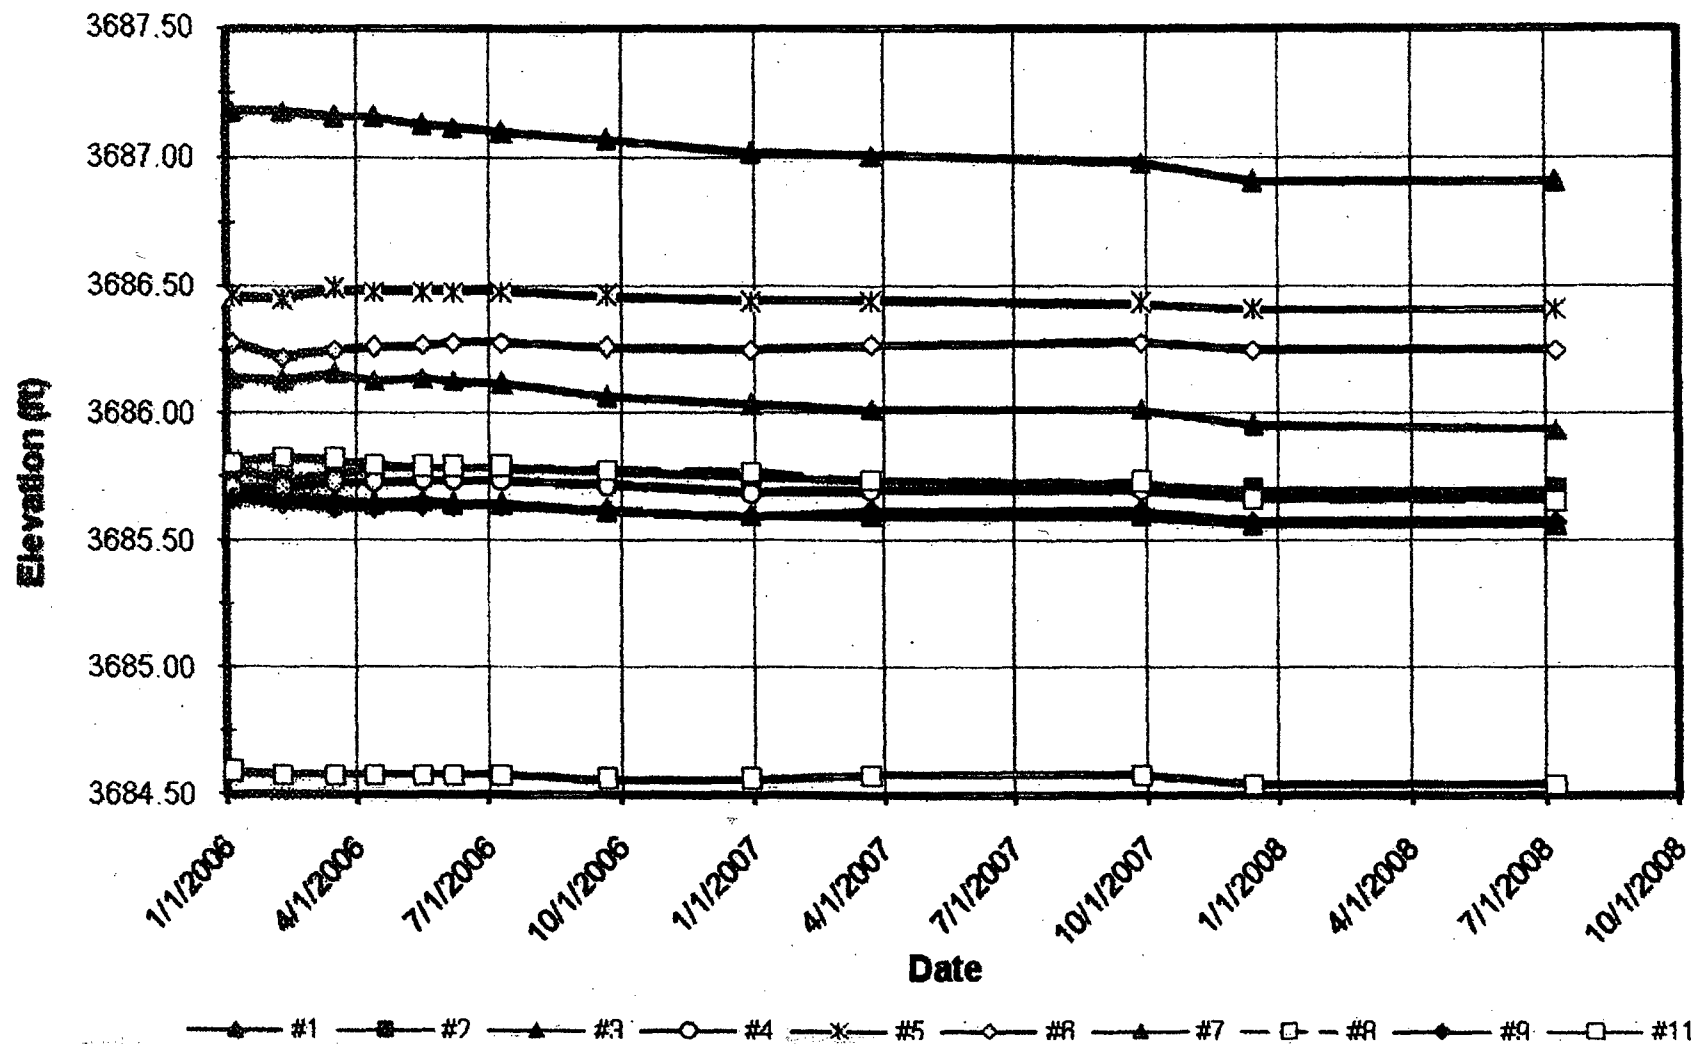
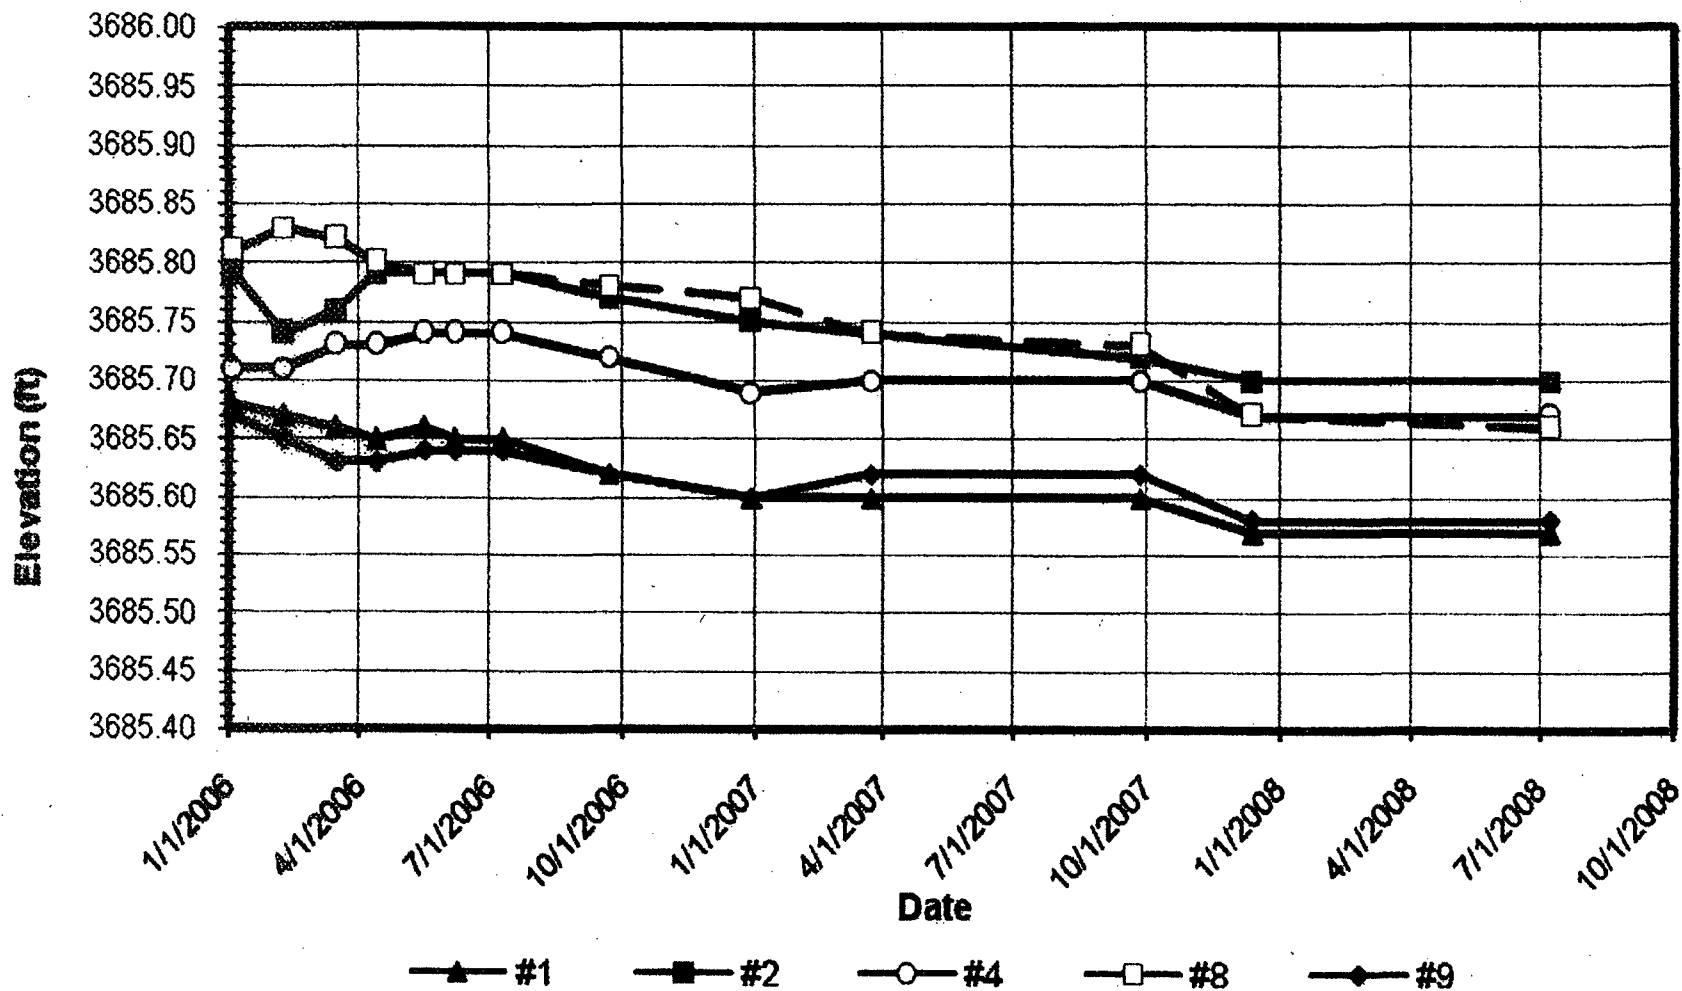
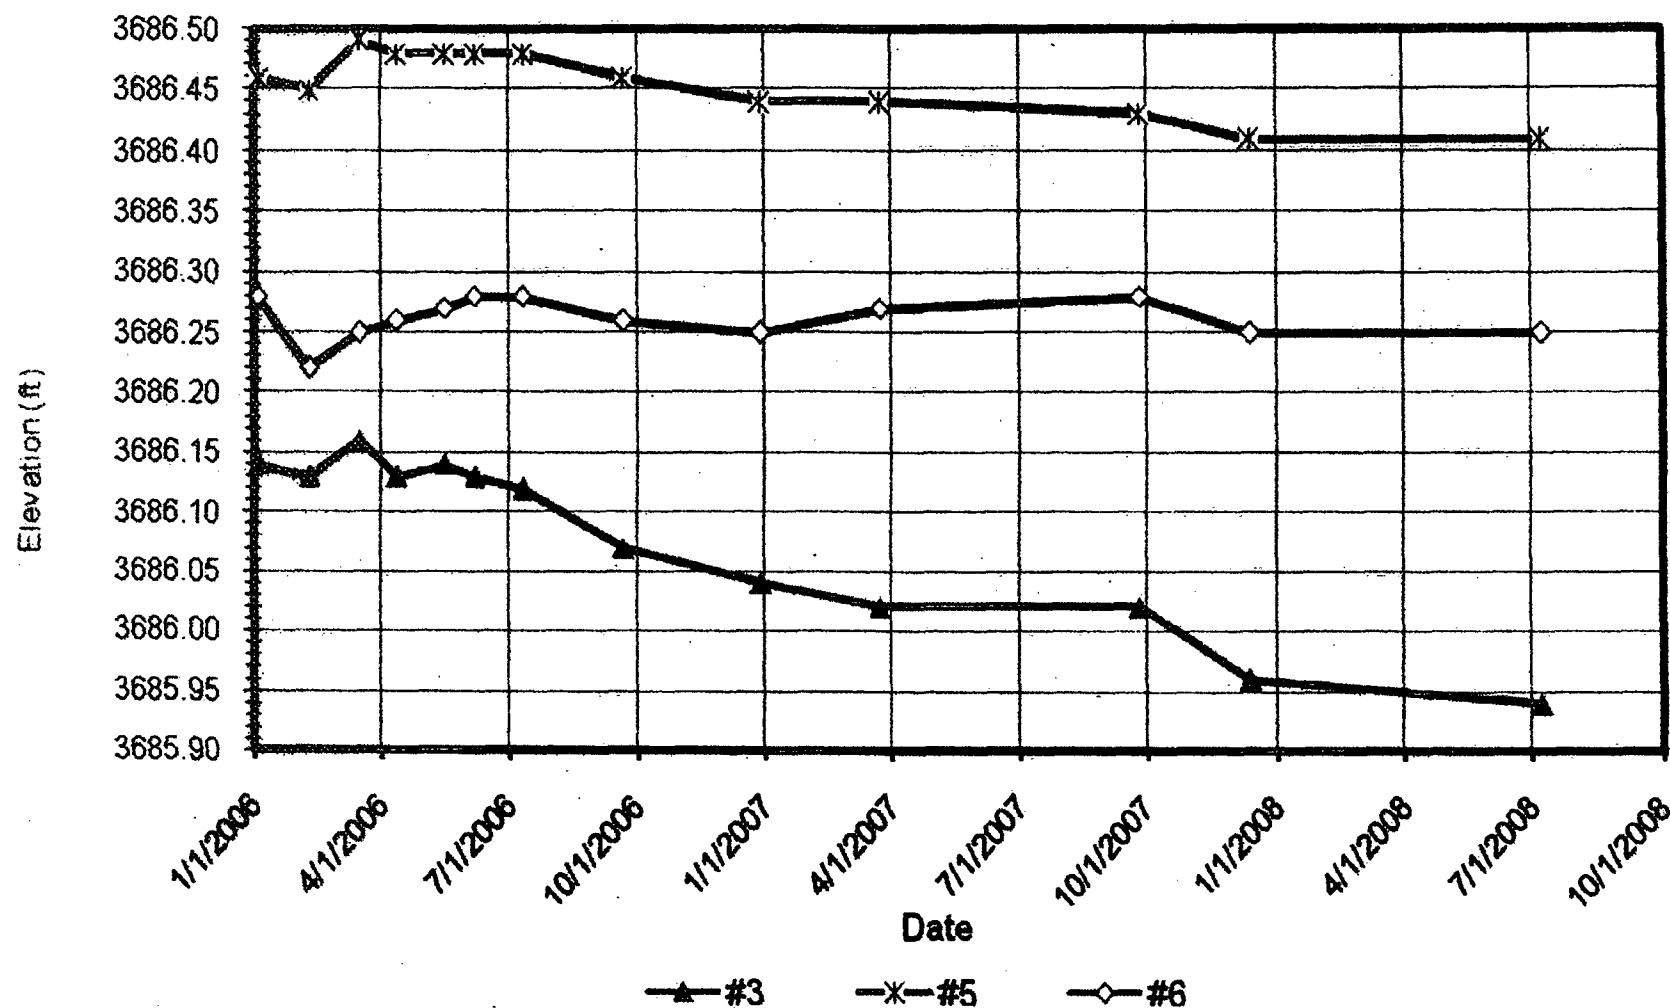
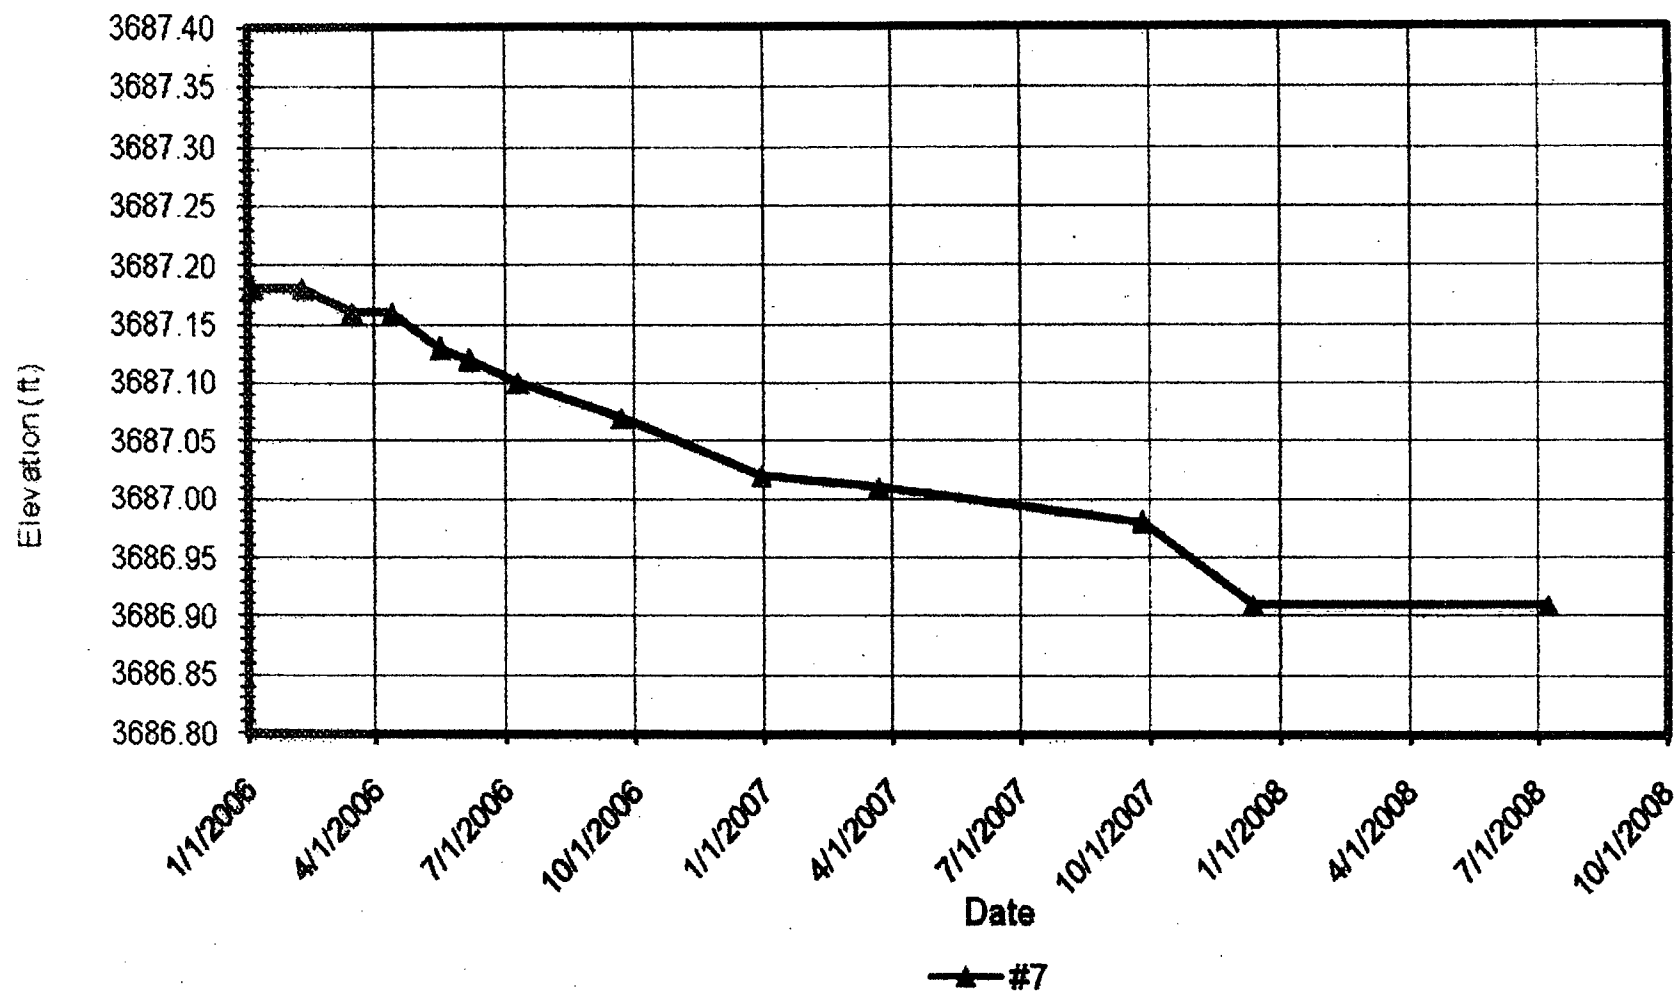
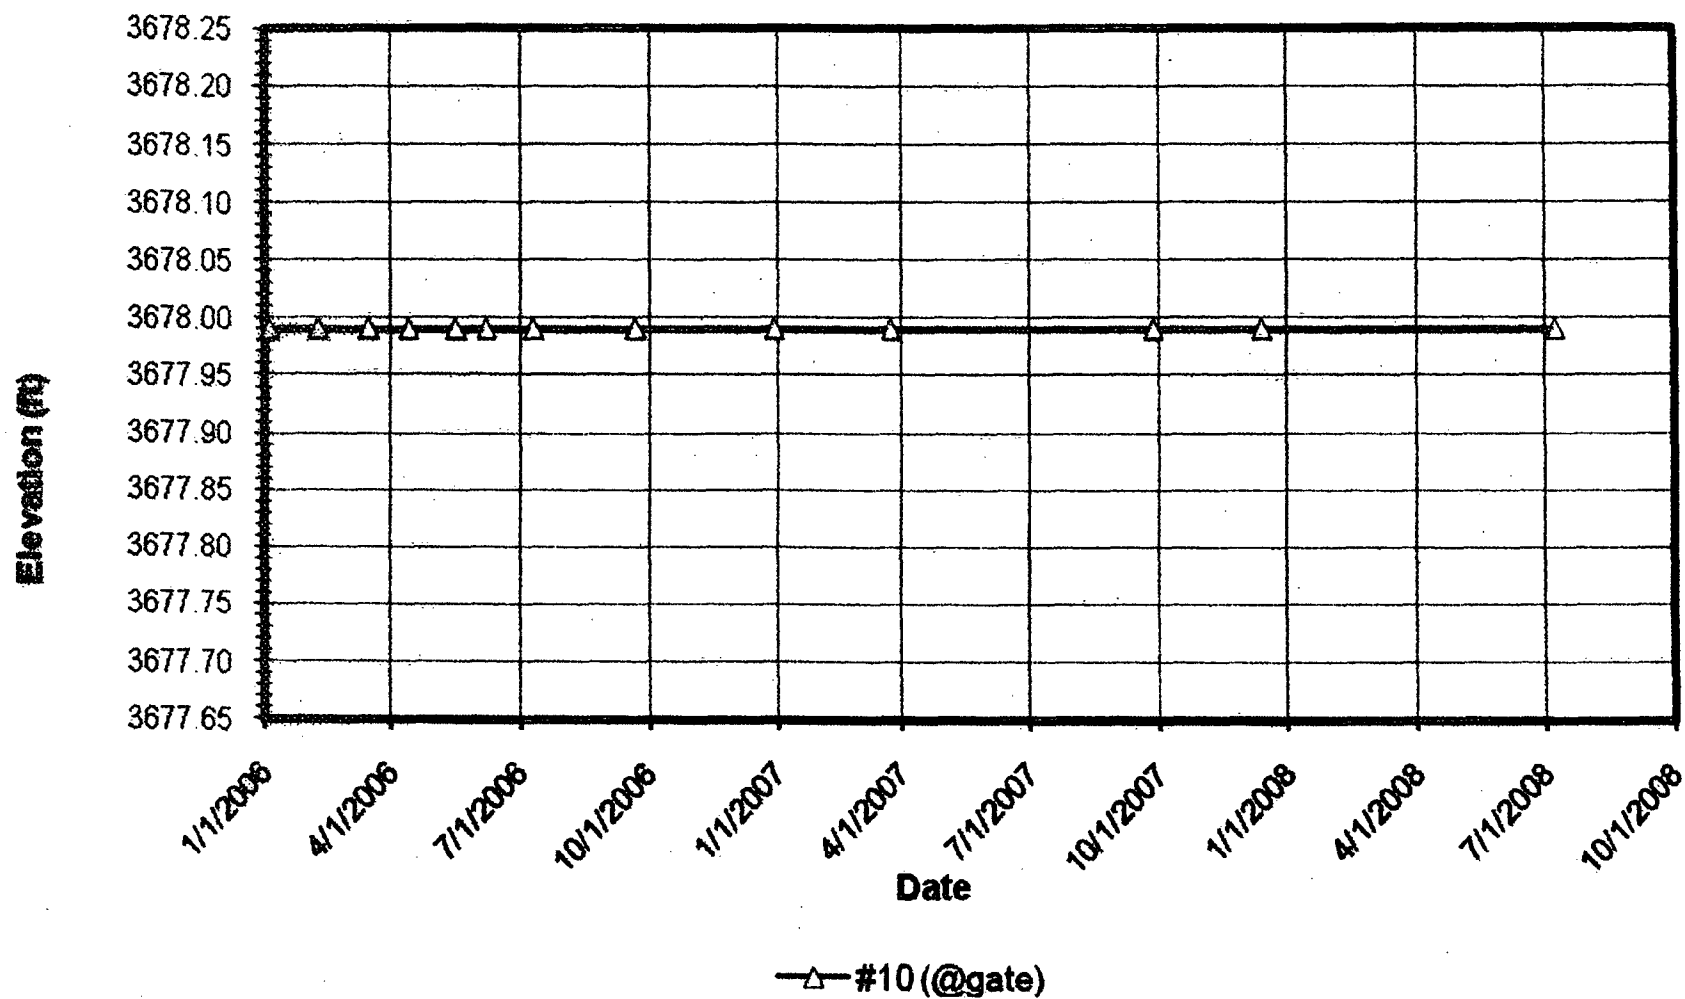
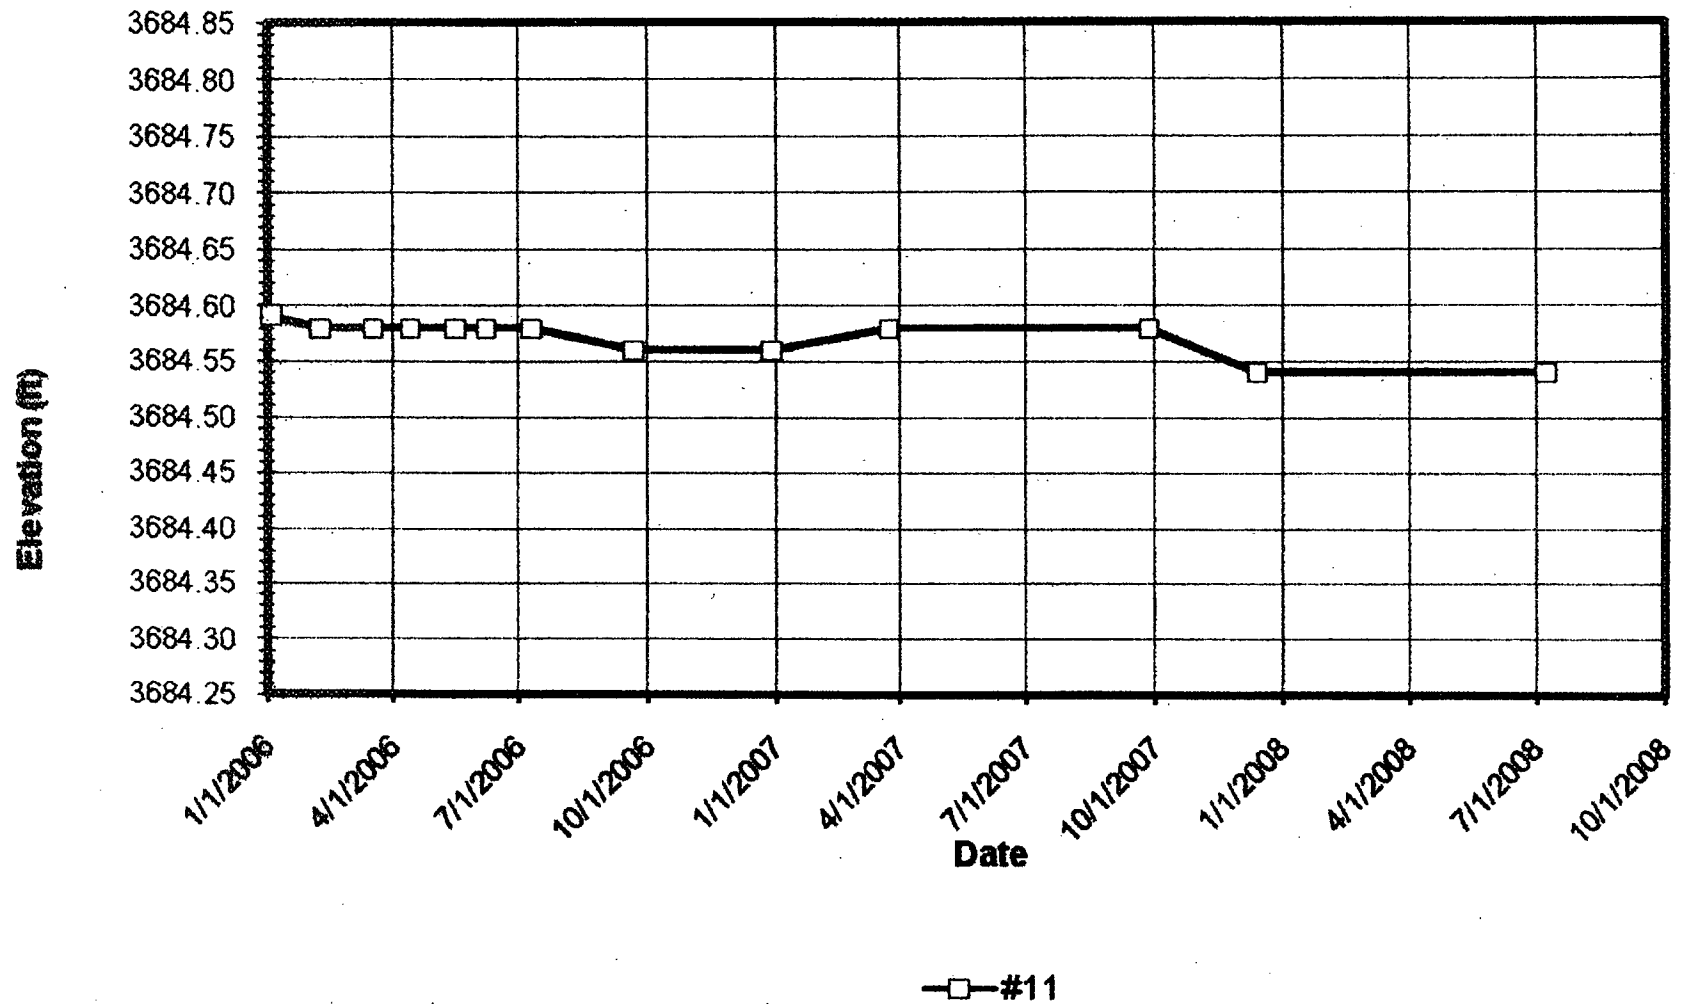
## Apex Pond 2 - Settlement Monument Elevations

Most apparent monument movement from period to period can be attributed to surveying accuracy limitations as the data shows individual monuments both increasing and decreasing in elevation. However, when data for all monuments is "corrected" by keeping the baseline monument's (#10) elevation change to zero, then a general trend of decreasing elevations becomes apparent.

In summary the data shows that roughly the northern half of the impoundment has settled between 0.05 and 0.27 feet. The southern half of the impoundment has remained very consistent with very little to no settlement (0.0 to 0.05 feet). The largest measured settlement is, as expected, near the center of the impoundment (monitor #7) at -0.27 feet. Slightly greater settlement in and nearer the center of the impoundment is to be expected as significant quantities of fill were placed in this area during construction. Additionally, greater settlement should be expected on the northern half of the impoundment based on the locations and methods utilized to place the original cover materials (prior to final reclamation activities). According to Chris Gypton and Alan Wilson, cover materials were initially placed in the southwest corner and generally moved across the impoundment towards the northeast corner. This created a mud wave of unconsolidated waste which moved towards this corner, and eventually a thicker deposit of unconsolidated waste materials.

There continues to be no concerns to date with settlement. There are no low spots and no signs of ponding rain water. As expected with long-term consolidation, the data shows that settlement rates are slightly decreasing over time. Consolidation of waste materials and final reclamation cover materials appears to be very minimal and decreasing. Additionally, it is highly unlikely that any liquids are leaving the impoundment.

All elevation data provided by Alpha Engineering is presented graphically on the following pages. The first graph shows all monuments (except monitor #10 the baseline point) on a scale that allows all data to be compared. The next five graphs have expanded "Y" axes scales in order to more clearly show elevation changes, and for ease of comparison between graphs. A monument location map (provided by Alpha Engineering) is attached on the last page of this document. Included on this map are contours showing approximate total settlement of the top surface since installation of the monuments.

Based on data collected to date, MEI recommends that Hecia continue with their current plan and collect elevation data semi-annually. Please contact me if you have any questions concerning this review.
